Accuracy check for infusion pumps using IDA 4 plus

Written by Ichiro Suzuki. Sendai Medical Center, Sendai, Japan

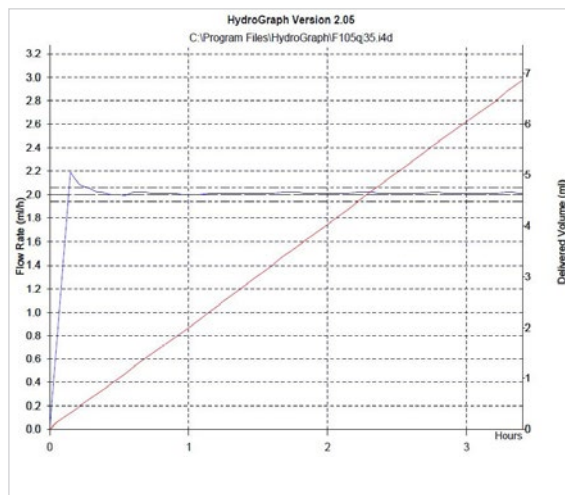
Figure 3. Normal data

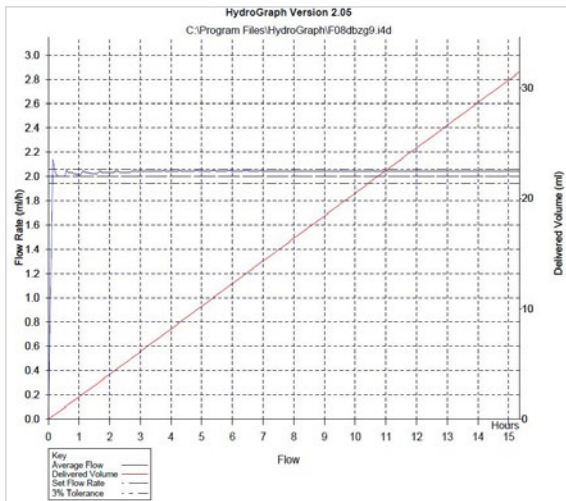
Figure 4. Incorrect pump flow rate found after more than 12 hours of an inspection re-flow.

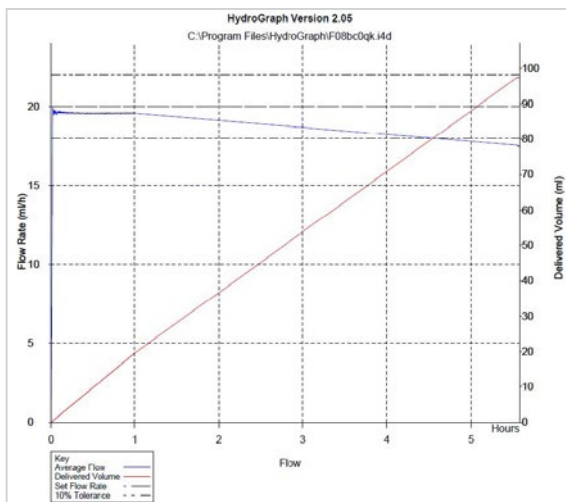
Figure 6. Infusion pumps, flow anomaly after 4 hours

of measurement, but thereafter began to decrease gradually, deviating from a normal range four hours after the start of measurement (Fig. 6). In some syringe pumps, abnormal flow rates were observed immediately after the start of measurement (Fig. 7) or three hours after the start of measurement (Fig. 8).

One infusion pump had abnormal flow rates four hours after the start of measurement. Similarly, one syringe pump had incorrect flow rates three hours after the start of measurement, suggesting it may be impossible to ensure reliable accuracy control by approximately one hour of measurement. Accuracy checks may require measurement over three to four hours as is performed in our hospital. On the other hand, four clinical engineers in our hospital are engaged in multiple clinical operations, and any of them cannot be exclusively committed to inspection duties. If the inspection takes one hour, they cannot concentrate on the other clinical operations. A Fluke Biomedical IDA 4 Plus infusion device analyzer, which allows several hours of measurement without supervision, sets them free from attendance for the flow rate measurement and enables them to perform other clinical operations instead. Using IDA 4 Plus, which allows accuracy check for four infusion pumps in parallel at once, accuracy checks can be performed for up to 16 pumps per day in our hospital. The flow rate inspection is associated with the following problems. First, inspection of pumps must be carried out with due attention to the status of use because the pumps cannot be available to use during several hours of inspection. Secondly, the results of flow rate inspection are currently recorded and stored on a paper basis. Given a huge amount of print-outs to be output in the future, it will be more desirable to record and store the results electronically rather than on a paper basis. Currently in Japan, however, regulatory audit of hospitals requires paper-based disclosure of data, warranting future studies on the validity of electronic recording and storing.

Since short duration of flow rate inspection has problems with accuracy control, at least three hours of flow rate inspection is desirable. Introduction of Fluke Biomedical IDA 4 Plus infusion device analyzers has led to an increase in the failure detection rate of infusion and syringe pumps and an improvement in safety. It may also contribute to more efficient operations by the clinical engineers. IDA 4 Plus is expected to reduce the duration of inspection and improve productivity because it ensures the inspection of

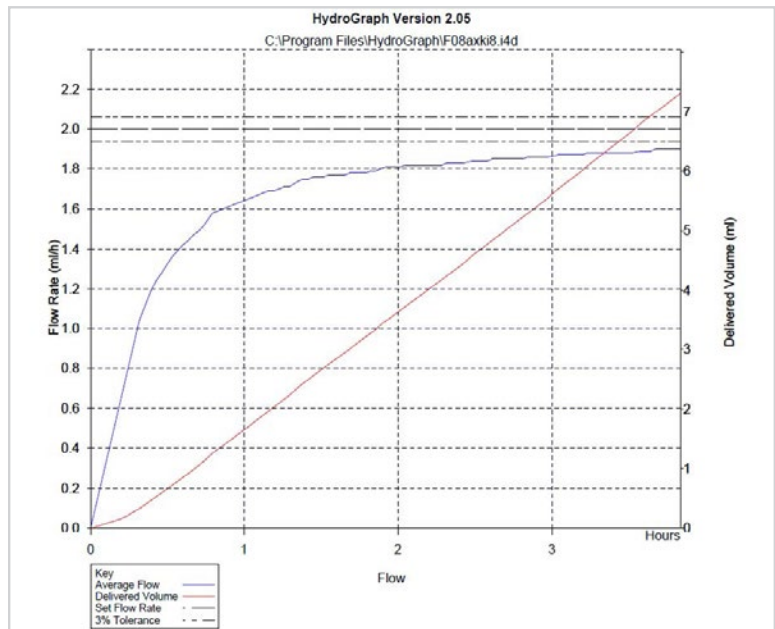
Figure 7. Syringe, flow anomaly

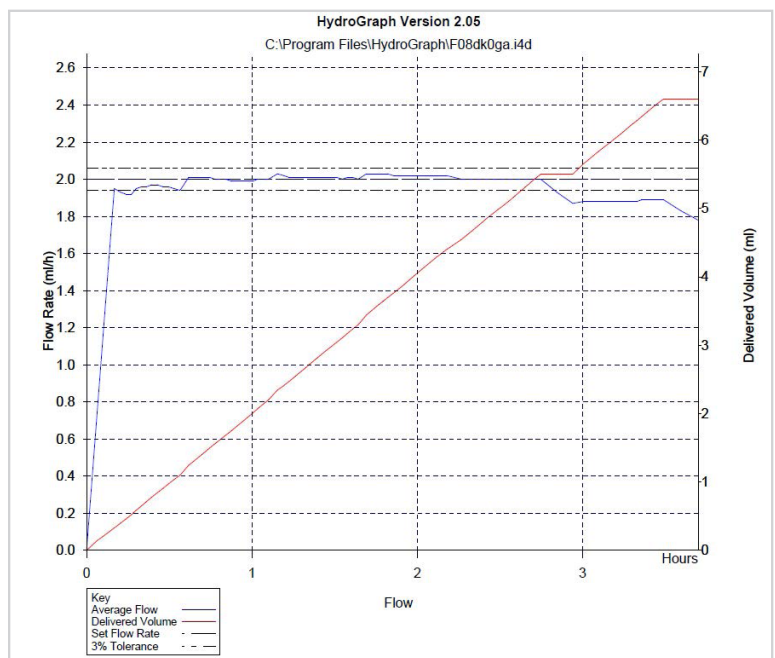
Figure 8. Syringe, flow anomaly after 3 hours
