Accuracy check for infusion pumps using IDA 4 plus

Written by Ichiro Suzuki. Sendai Medical Center, Sendai, Japan

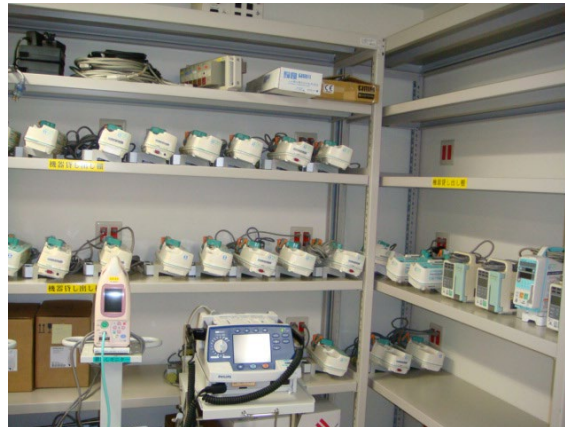
Figure 1. Centralized storage syringe infusion pumps

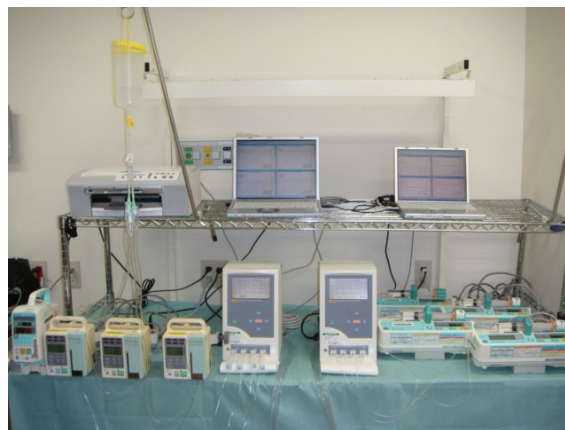
Figure 2.

In our hospital, accuracy checks are performed every month for all infusion and syringe pumps, in principle, using two Fluke Biomedical IDA 4 Plus infusion device analyzers and distilled water (Fig. 2). For accuracy checks, the flow rate is measured over three to four hours for each pump with a flow accuracy of $20 \text{ mL} \pm 10 \%$ for infusion pumps and $2 \text{ mL} \pm 3 \%$ for syringe pumps (Fig. 3). For any infusion pump with incorrect values, the test is repeated over 12 hours or more to confirm the flow rate (Fig. 4). Upon completion of the inspection, a flow rate inspection report is printed out and filed in the equipment control register. All inspected infusion and syringe pumps are marked with a sticker showing inspection completion in monthly different colors and are then available for rent.

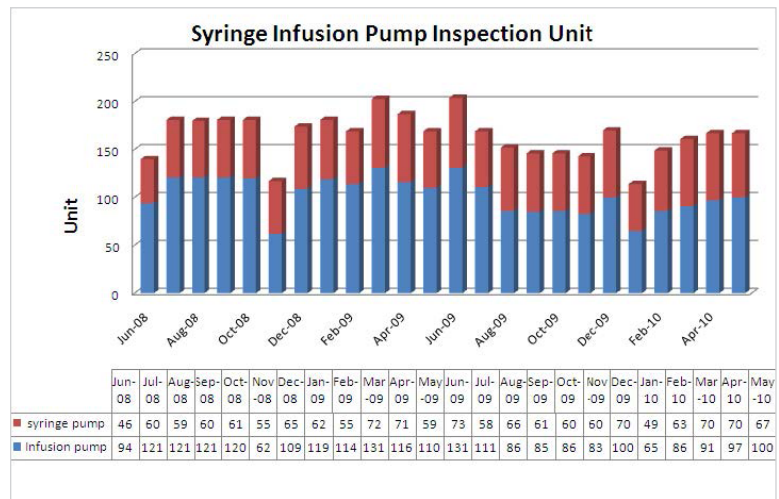
Figure 5. Syringe infusion pump inspection unit

The number of infusion and syringe pumps inspected every month is shown in Fig. 5. During the period, a total of 2,459 infusion pumps were inspected, with a monthly mean of 102 ± 9 pumps. In this period, incorrect flow rates were observed with 4 infusion pumps, resulting in a failure detection rate of 0.16 % relative to the total number of pumps inspected (hereinafter referred to as the failure detection rate) and a failure rate of 2.9 % relative to the number of pumps possessed (hereinafter referred to as the failure rate). During the period, a total of 1,492 syringe pumps were inspected, with a monthly mean of 62 ± 7 pumps. In this period, abnormal flow rates were observed with seven syringe pumps, resulting in a failure detection rate of 0.46 % and a failure rate of 8.4 % (Table 1). In one infusion pump with abnormal flow rates, the flow rate was stable until one hour after the start
